Concrete Efflorescence

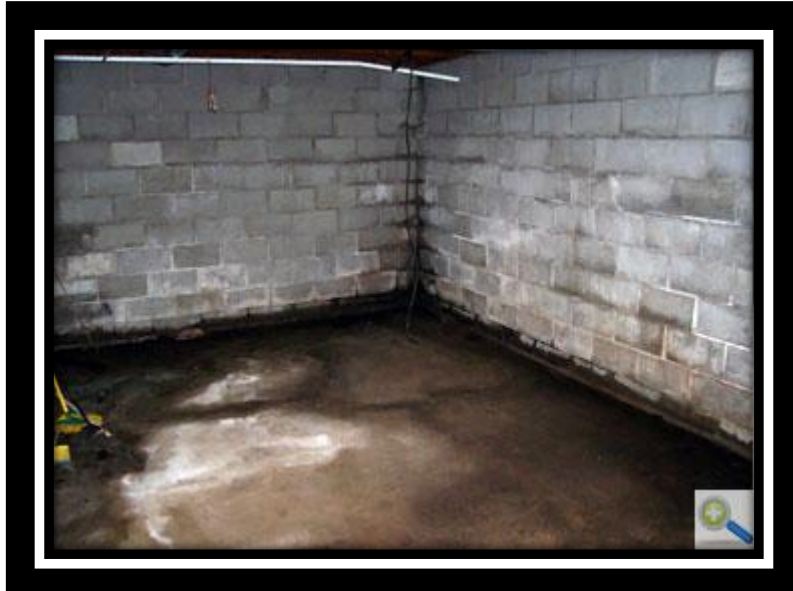
White, flaky powder coating concrete walls and floors is caused by a naturally-occurring mineral salt called "efflorescence". This is a powder that's left behind as water vapour passes through the concrete walls and floors. Over time, these mineral deposits build up in layers so thick that it's sometimes mistaken for mould.

Efflorescence is a messy problem, but the problem is cosmetic only, it won't stain, and there are no known health issues connected with it.

As water passes through the concrete, it brings minerals with it. The moisture then evaporates into the basement, leaving these minerals behind. Over time, the build-up on the concrete creates the efflorescence that you see.
